The Influences of Geologic Depositional Environments on Sand Boil Development, Tara Wildlife Lodge Area in Mississippi

Ryan C. Strange, Maureen K. Corcoran, Joseph B. Dunbar,
and Darrel Schmitz

March 2016

Final report

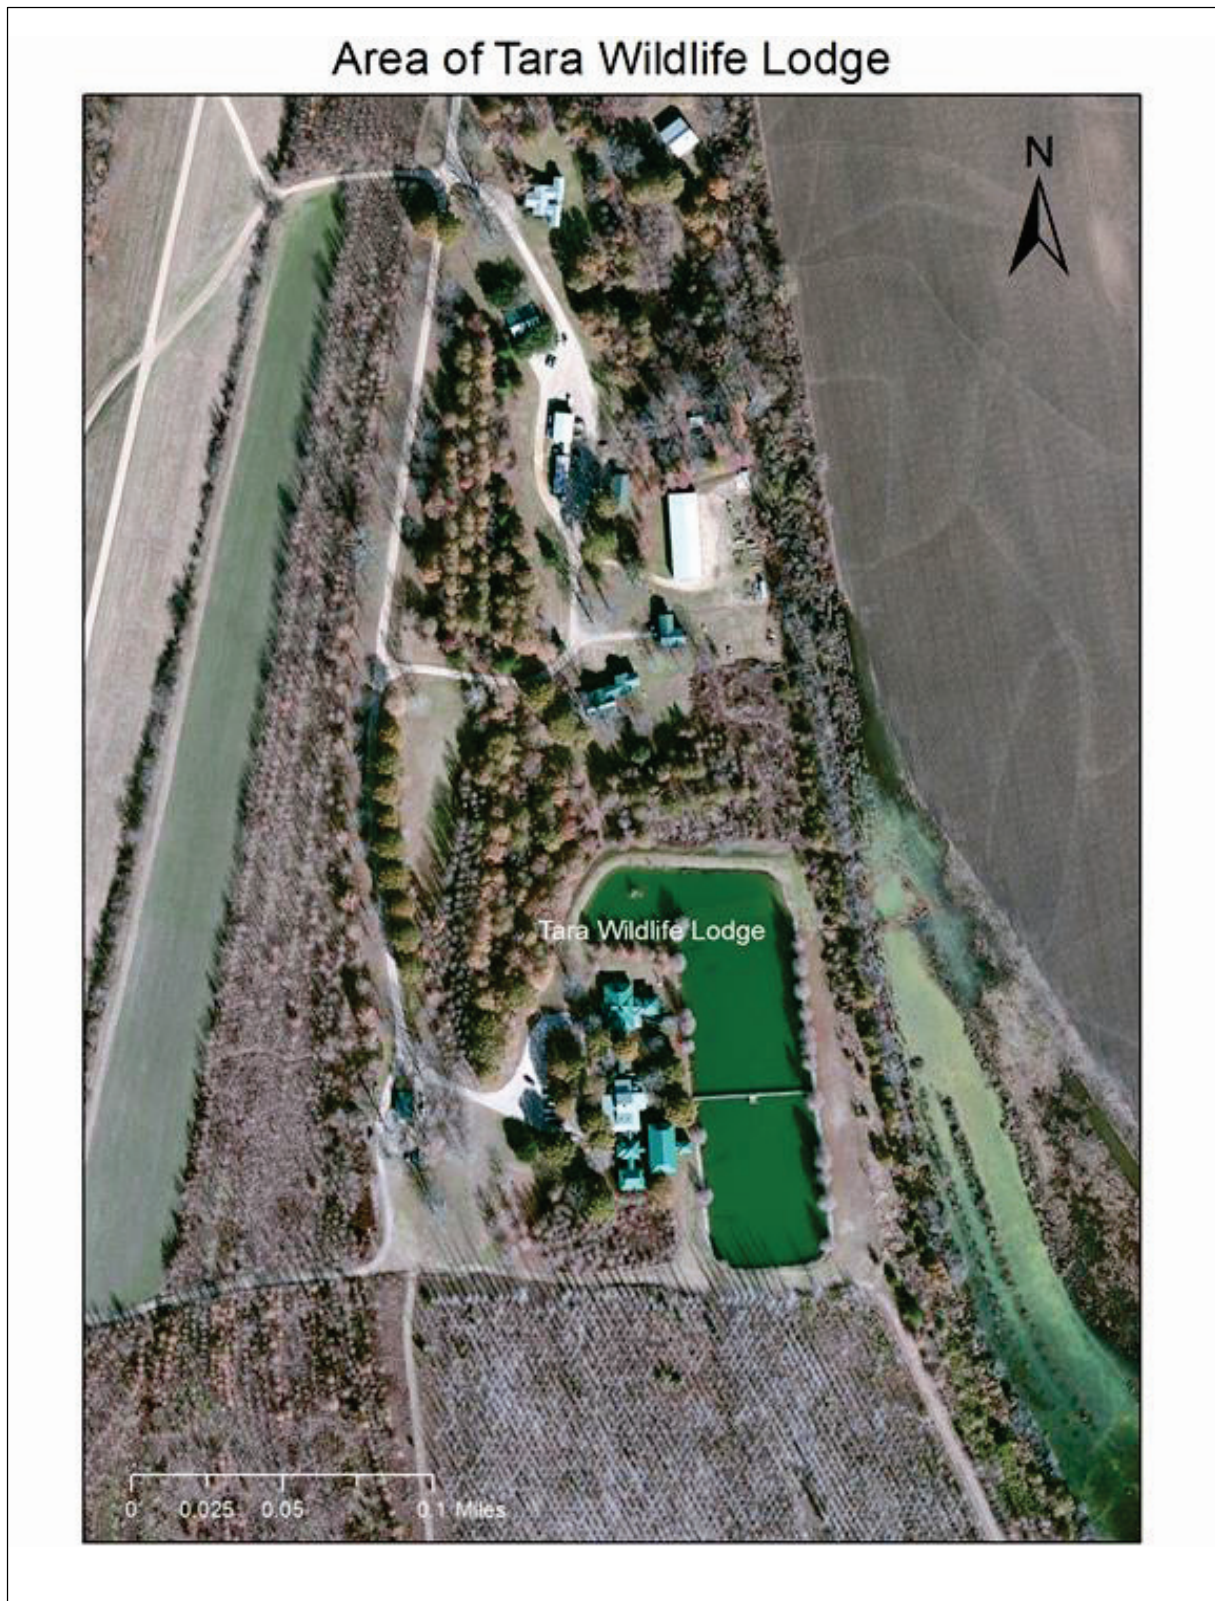
Figure 4. Map of Tara Wildlife Lodge (ESRI 2014).

The Tara Wildlife Lodge area (Figure 4) has been known for having sand boil issues since the placement of the Muddy Bayou Control Structure following the devastation of the 1973 flood. The Muddy Bayou Control Structure regulates the allowance of water into Eagle Lake from the backwaters of the lake (landside). Before the placement of the Muddy Bayou Control Structure, there were no known sand boils occurring in the Tara Wildlife Lodge area. When a flood event occurred, the water surface of Eagle Lake, which is on the landside of the levee, would rise until the piezometric surface reached equilibrium. This meant that the head differential between the riverside and the landside was not enough for sand boils to develop.

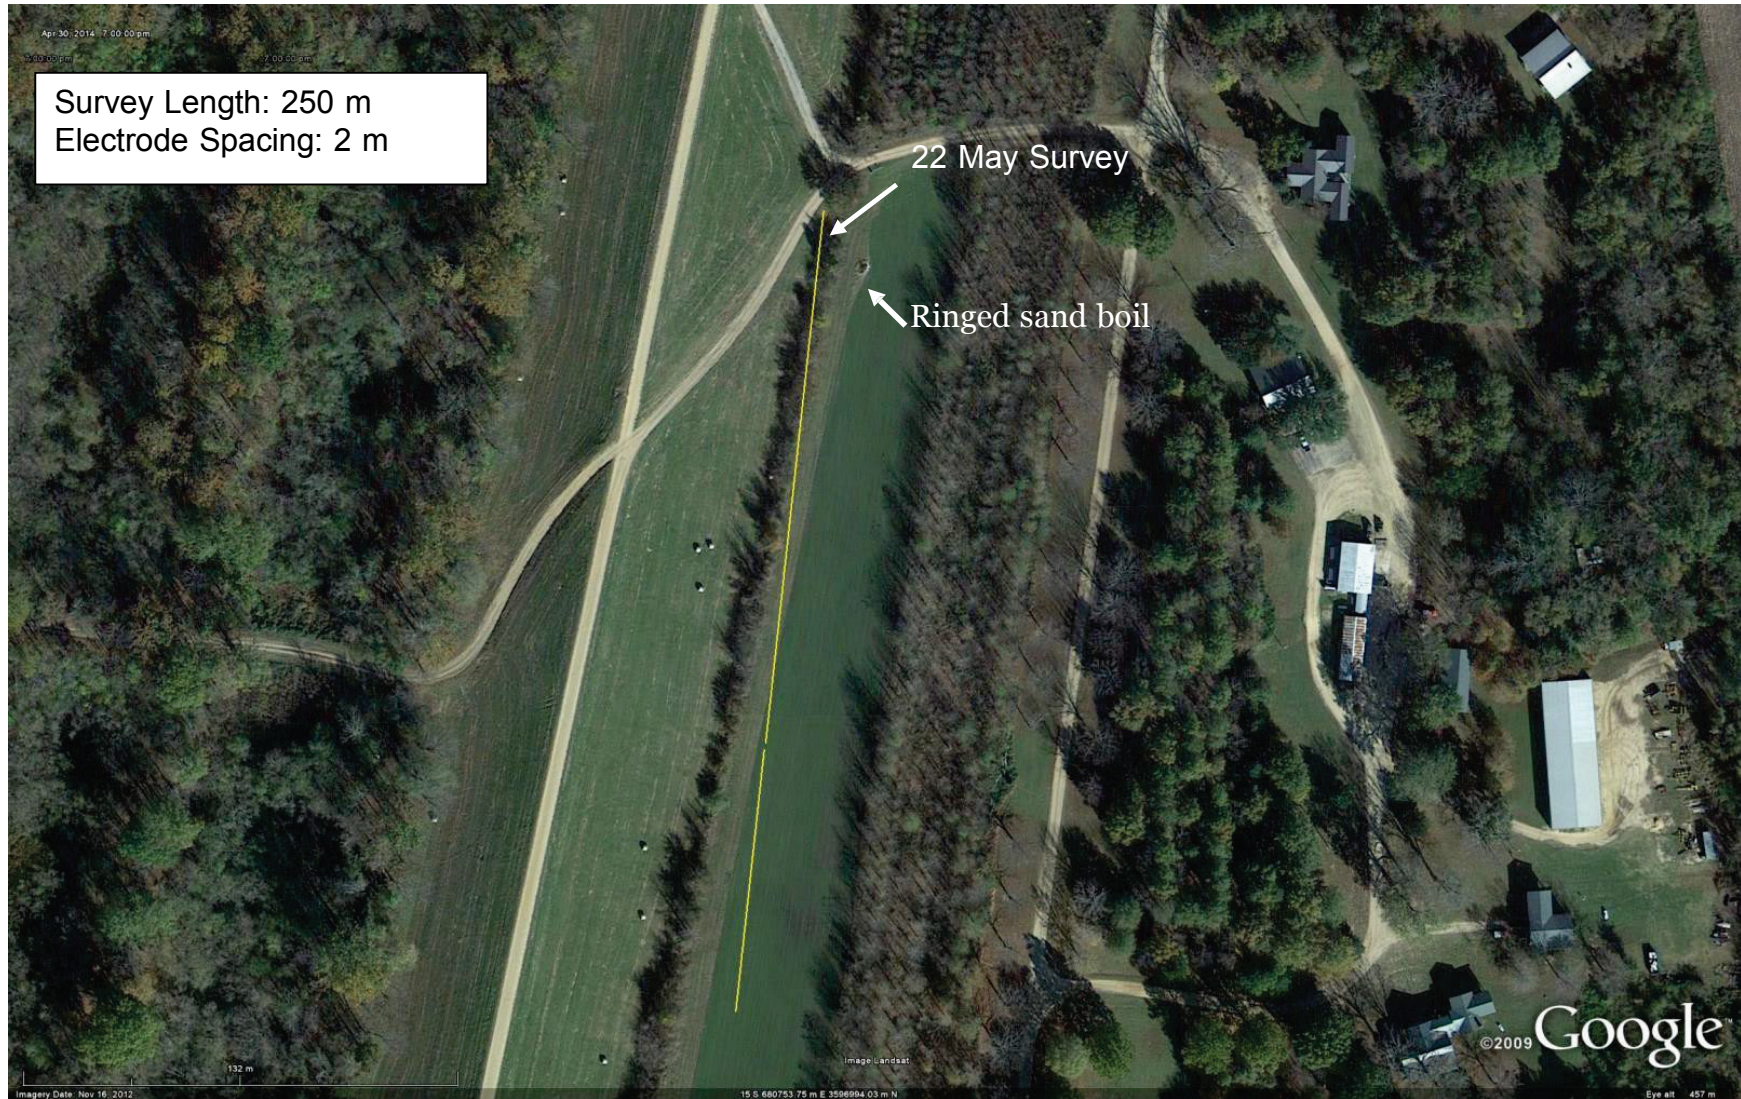
Figure 20. Northern ERT survey transecting areas of seepage. Notice ringed sand boil (Google 2009).

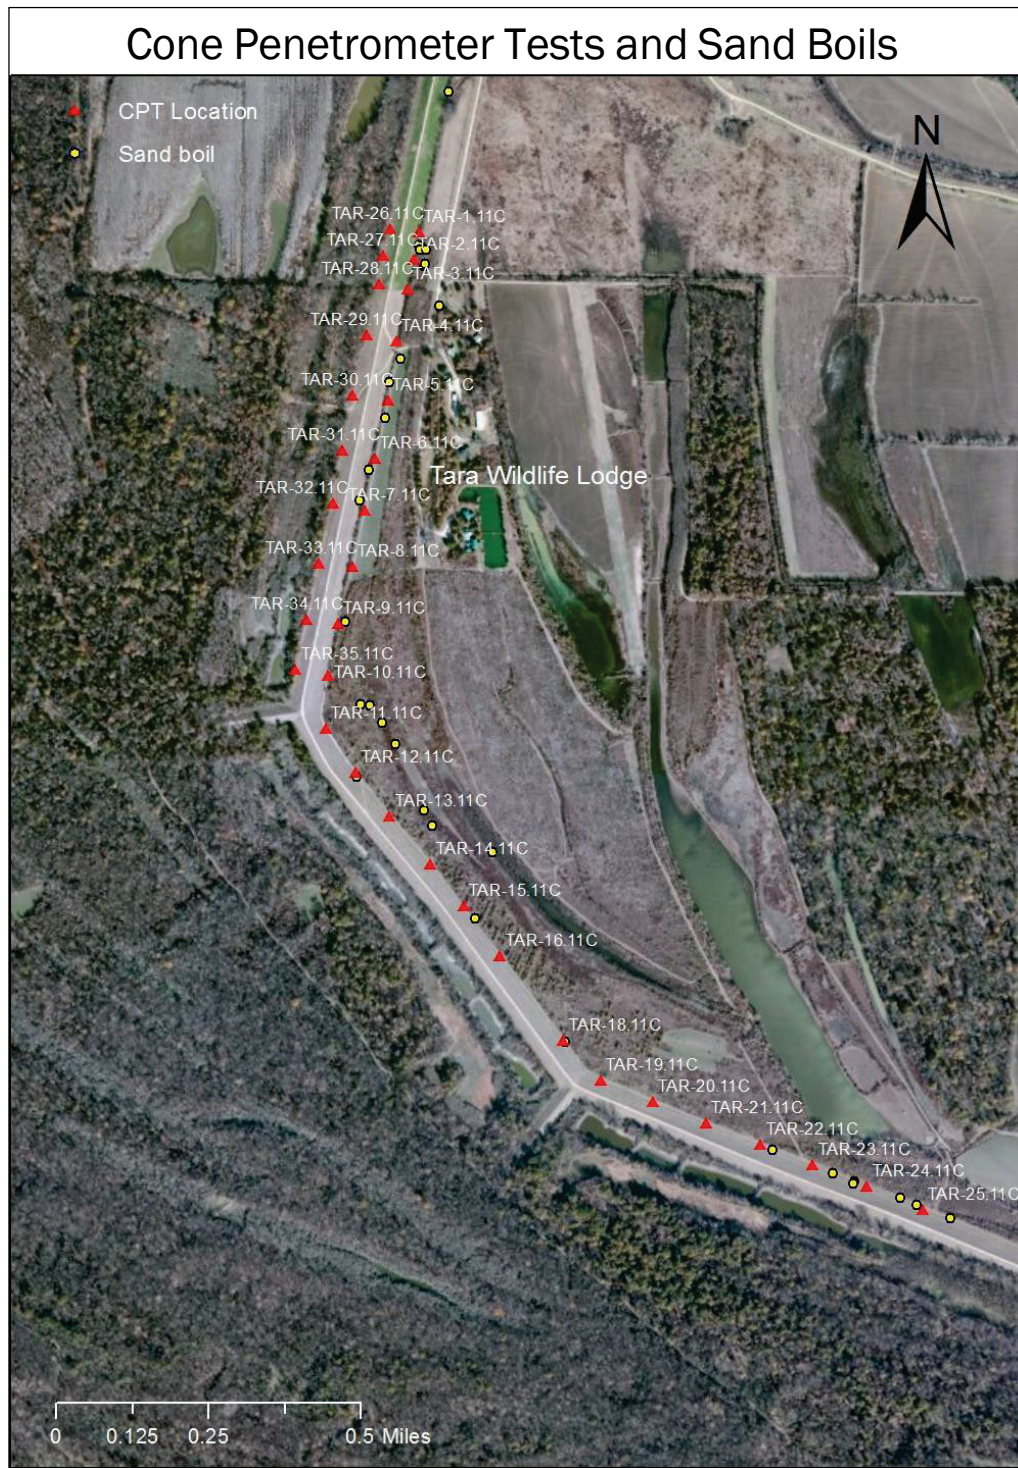
Figure 34. Map of cone penetrometer tests and location of sand boils from MICA data from the 2011 flood (ESRI 2014).
